Triac Assembly Replacement

Procedure to replace the Triac Assembly in Model 500S

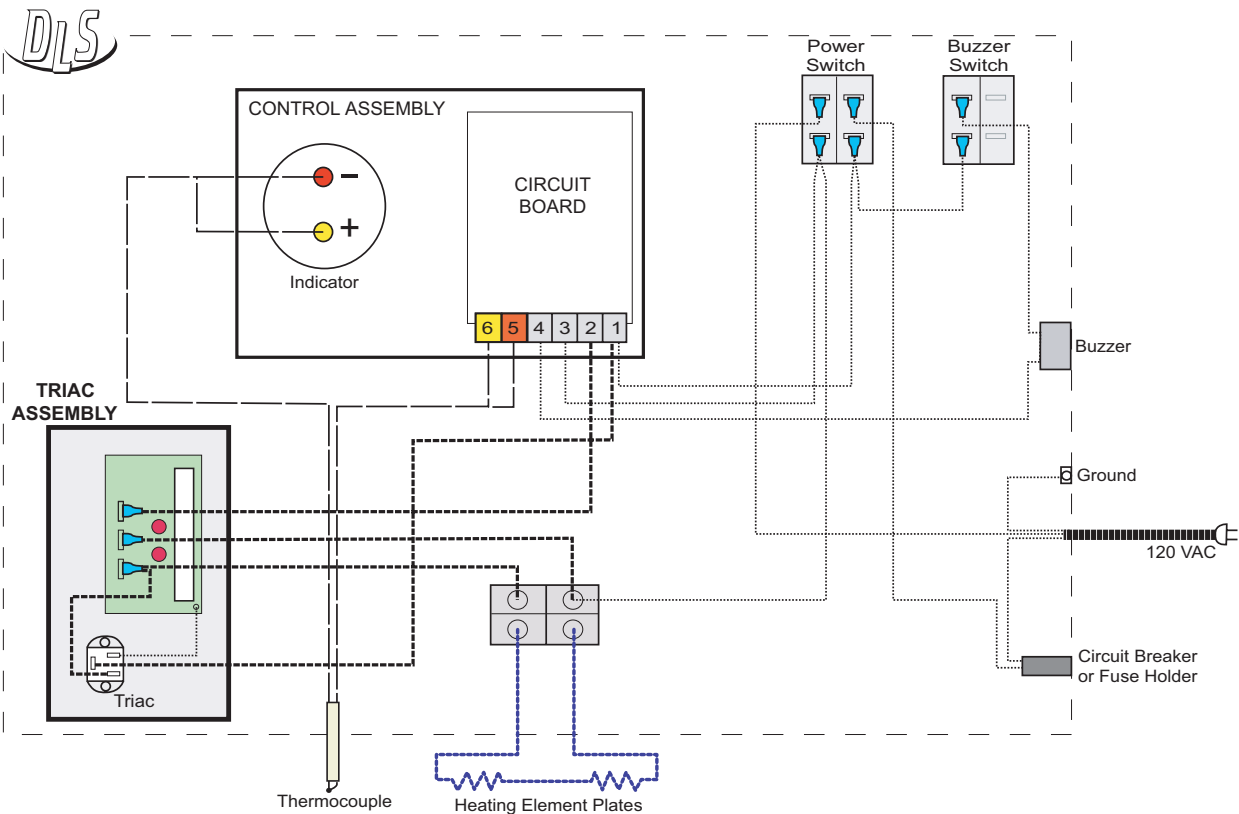
1. Unplug oven and empty the oven of all rings, debris and porcelain trays.
2. Wait for oven to cool down and then turn the oven upside down carefully and remove the bottom panel (6 screws).
3. Unscrew the triac assembly to the side oven wall and replace with new triac assembly noting where the wires went. (If your old triac assembly is not the same, please call us for the "Classic Triac Assembly Sheet".)
4. Connect the wires to the new triac assembly as you disconnected them and screw the assembly back on.
5. Make sure that the heating element wires are not touching the insulated wires or anything else.
6. Replace the bottom cover with the six screws and turn upside down. Your oven is now ready to operate.
